Radon Inspection Report

RP22304130027_19May23_1736

209 JOSIE LN

CLARKSVILLE, Tennessee 37043

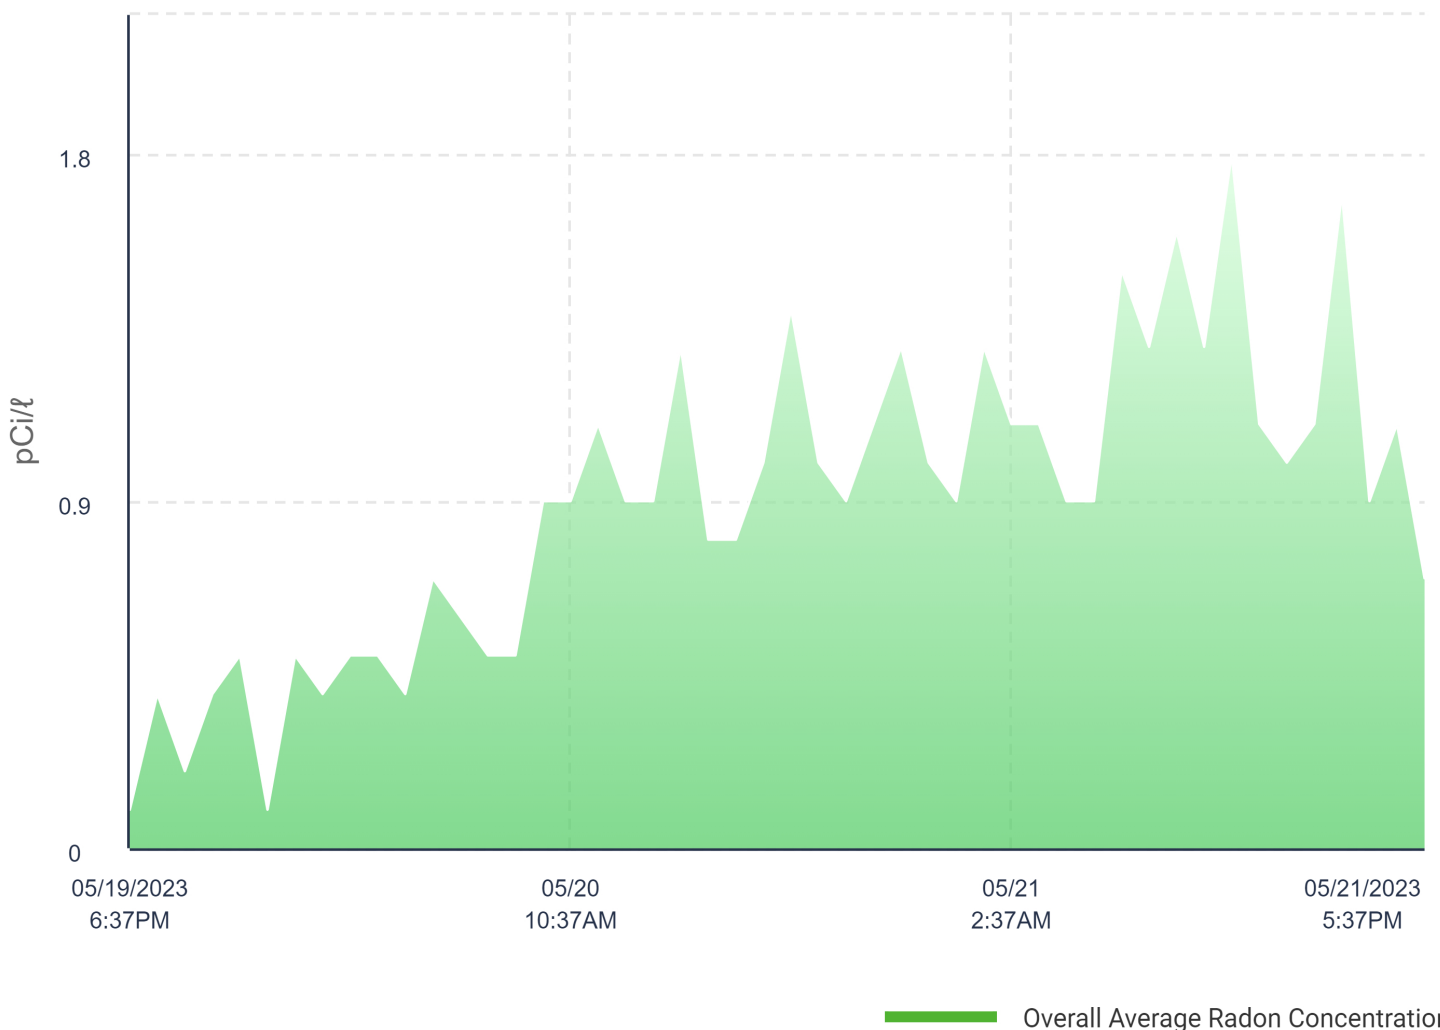
Historical Radon Trend

0.9 pCi/ℓ

Your EPA Protocol Average Radon Concentration was measured at 0.9 pCi/L. This falls below the EPA's recommended action level of 2.0 pCi/L, which means your home was safe from radon at the time of this test. We recommend you retest in five years, if any structural changes are made to the soil below and around your home (installation of sump pump or French drain, etc.), or if you sell the property.

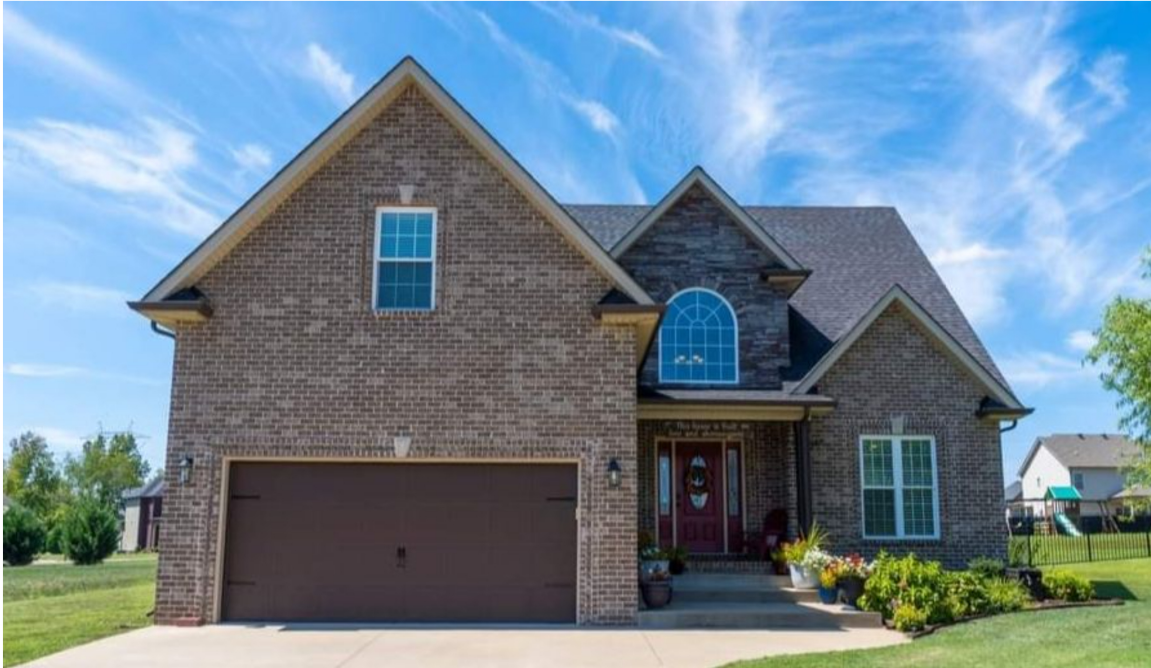
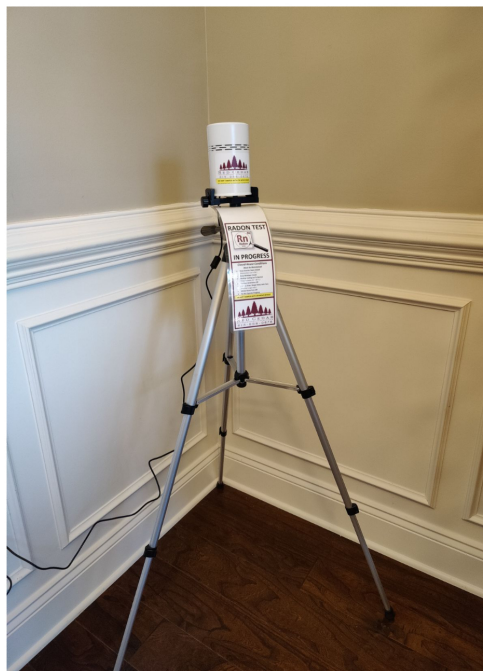
MEASUREMENT ENVIRONMENTS

Two RadonEye Pro Continuous Radon Monitoring devices were placed on a tripod in the NW corner of the front dining room in accordance with manufacturer and NRPP recommendations. The devices were left in place for a period of 48 hours. At the conclusion of the testing period, the devices were collected and the results compiled herein.
